Analysis of Lighting Fixtures

MMR Project No. 82999

MassDOT
Boston, MA

April 5, 2011

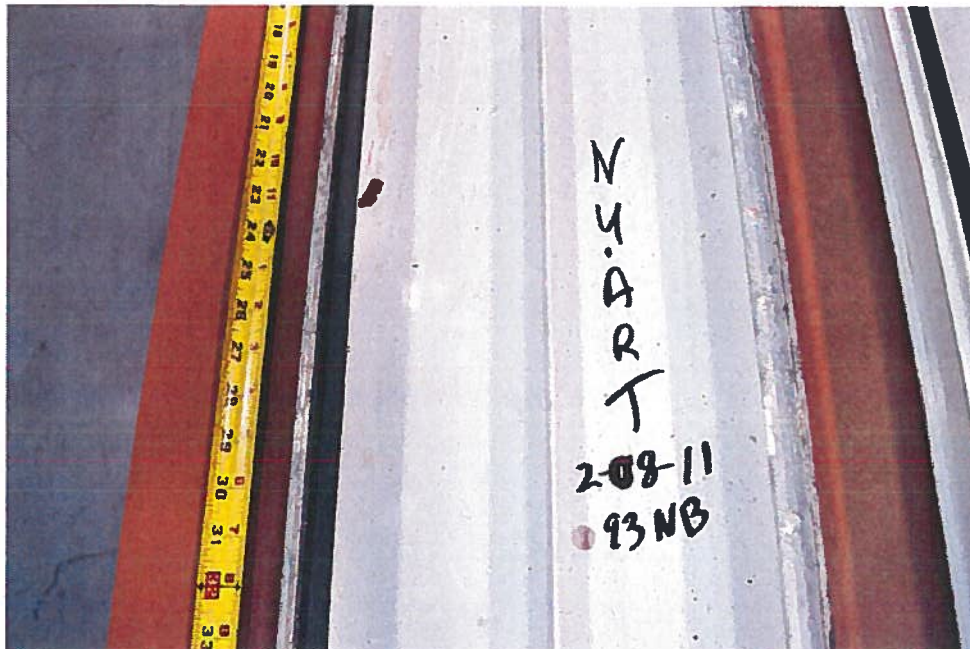
Figure 2: Incident wireway label. Note corrosion and lack of white coating on sides.

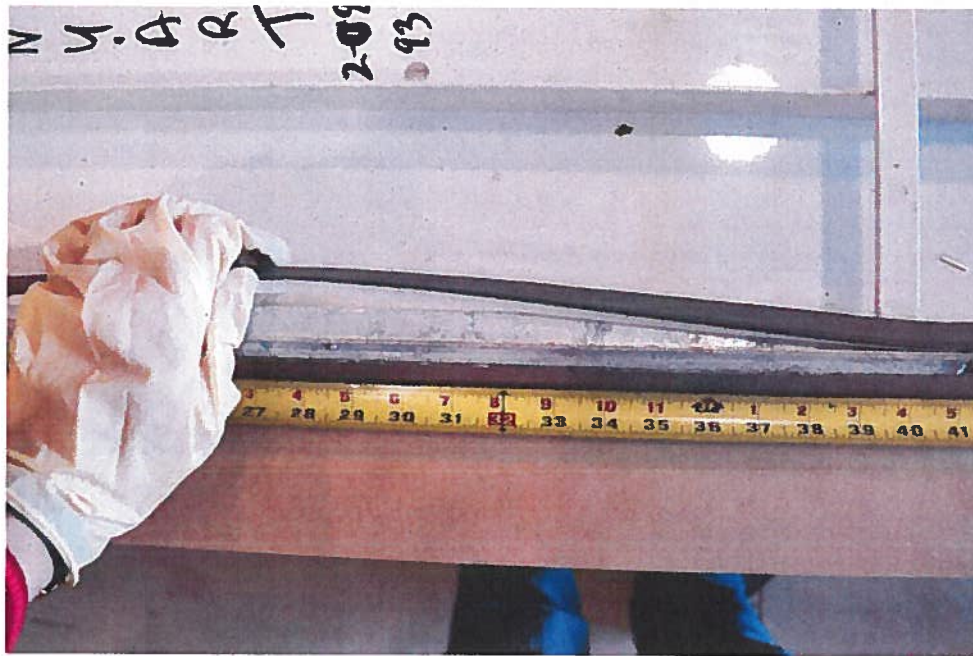
Figure 3: Corrosion was present under the white coating at the gasket.

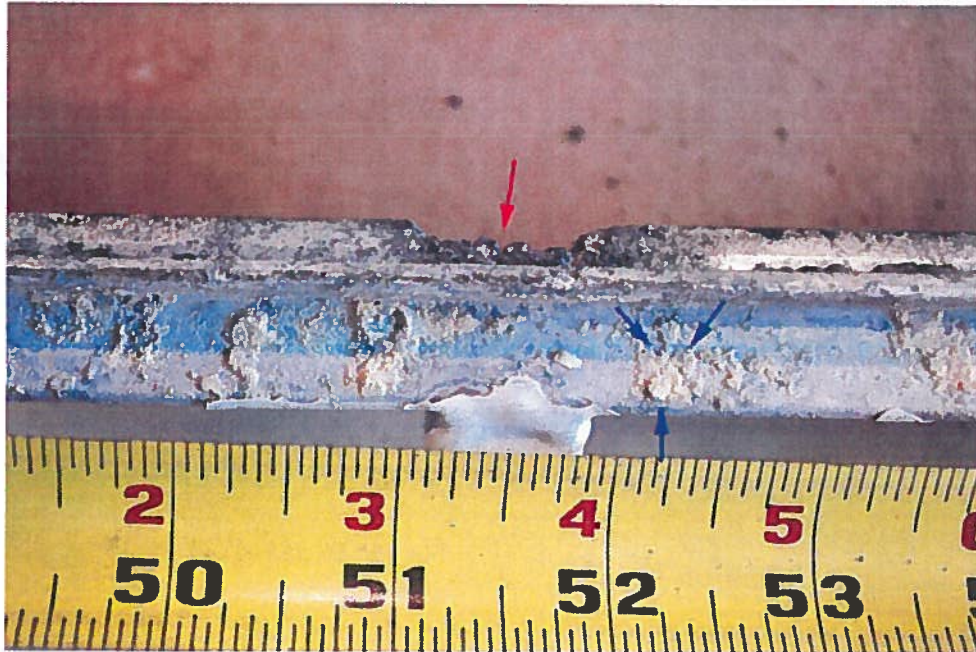
The failed wireway showed complete consumption of material at the lip locations where the clips were attached. All ten locations of the wireway revealed complete consumption of the lip width. This indicated that for this particular fixture, corrosion of the lip areas, where the clips were attached, initiated and propagated at about the same rate. The light fixture disengaged or fell apart from the wireway when the material at the mentioned locations was consumed.

Figure 4: Wasted wireway metal at a former clip location, red arrow. Corrosion debris, blue arrows, was present wherever coating could be removed.

We suggest removing the retention clips from the present locations to other areas of the lip where only surface corrosion is noted. Even in the absence of the powder coat, it should take about 3 to 4 years for the wireway lip thickness to be completely consumed based on the corrosion noted at the engagement locations of the failed wireway. Note that the subject failed wireway was in service for about 8 years. This assumption should be valid if the light fixtures experience the same environmental conditions as the failed one.

We would also strongly recommend checking the engagement locations for corrosion periodically, for instance, every six months. Both the wireway and light base should be examined for corrosion. If material wastage is noted during this examination, moving the clips again is recommended.

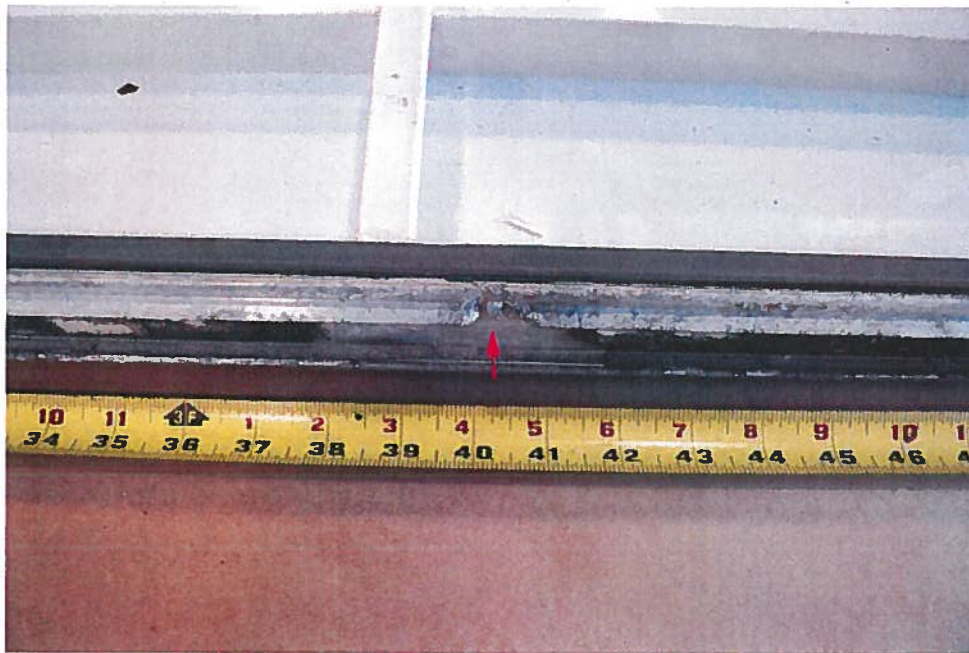
Figure 5: Another clip location, arrow.

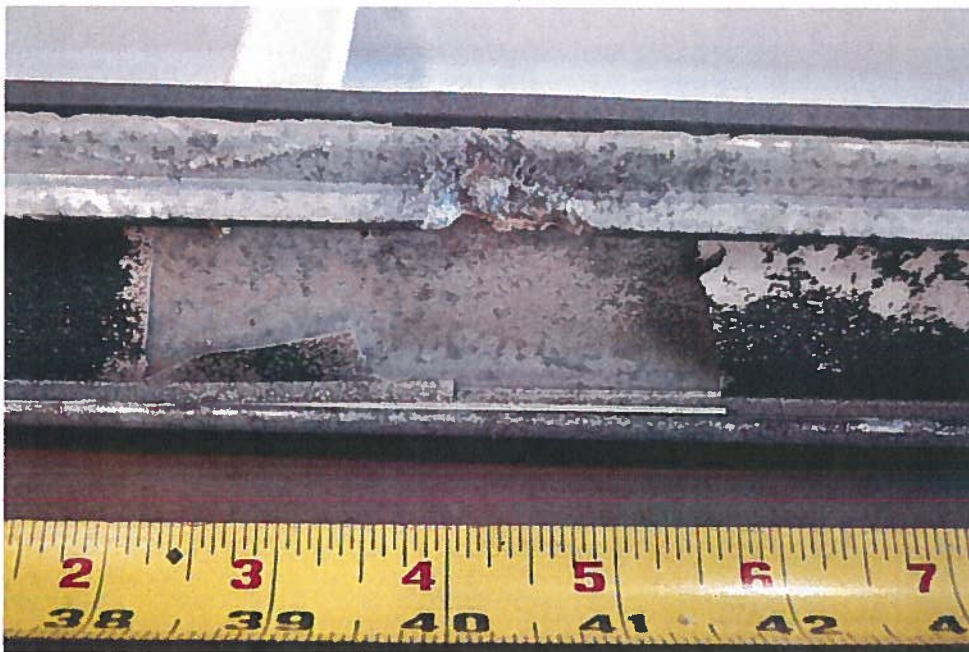
Figure 6: Detail of Figure 5 clip location. Also note soot-blackened paint surface on side rails.

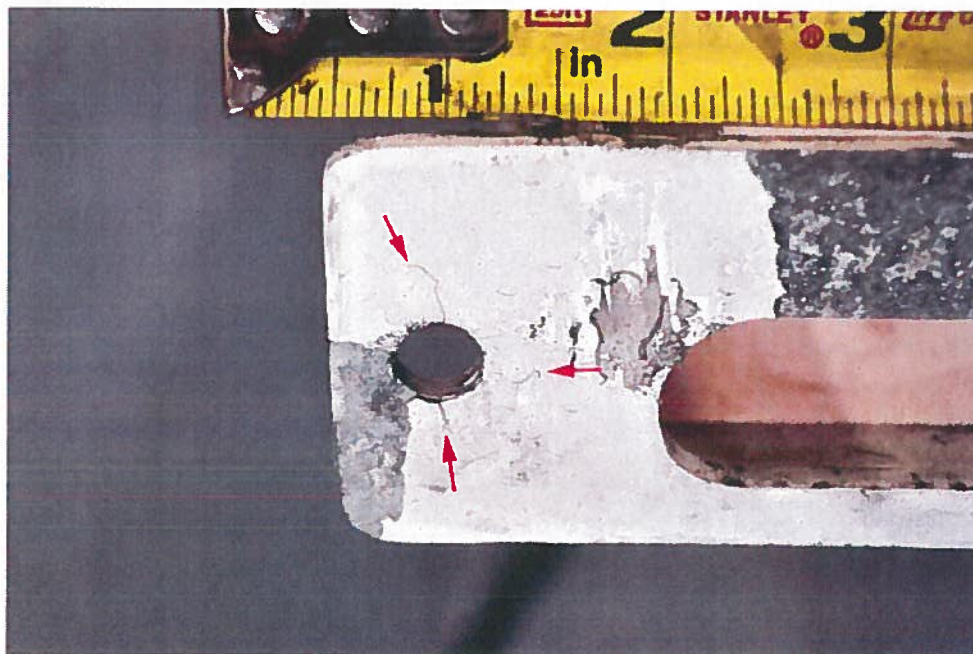
Figure 8: Incident wireway end cap at screw hole; note paint cracks emanating from hole, arrows, and lack of paint in hole.

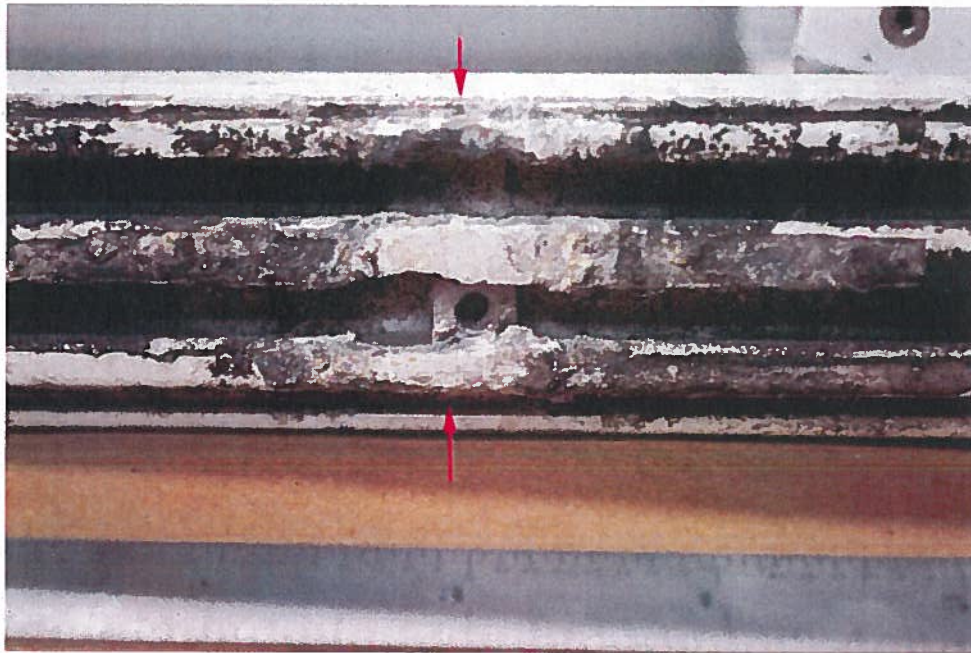
The base of the light fixture which was attached to the wireway revealed corrosion at the locations where the clips were screwed on. However, the corrosion did not appear to be as significant as the wireway engagement locations. Away from the screwed on clip locations, peeling off of the coating was noted from the substrate with whitish/yellowish debris on the aluminum substrate. The areas away from the clips did not reveal any evidence of significant corrosion of the aluminum base.

Figure 11: Clip locations on the incident light base also exhibited metal wastage, arrows.

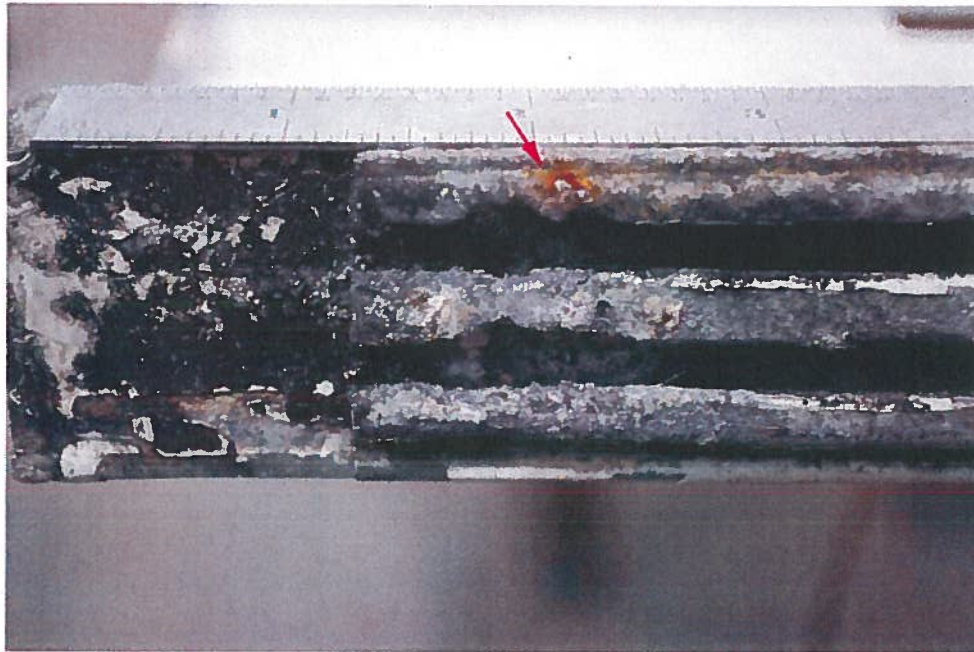
The clip we have examined did not show any corrosion. However, we have noticed some rust colored deposit on the failed large fixture base. This would indicate that some of the clips may have shown some corrosion. It is not the requirement in a crevice corrosion situation that the 300 series SS clips will have to corrode. It may or may not show evidence of corrosion depending on whether it is anodic or cathodic to its mated material.

Figure 12: Isolated rust-colored regions were present at clip locations on the incident light base, arrow, but they were rare.

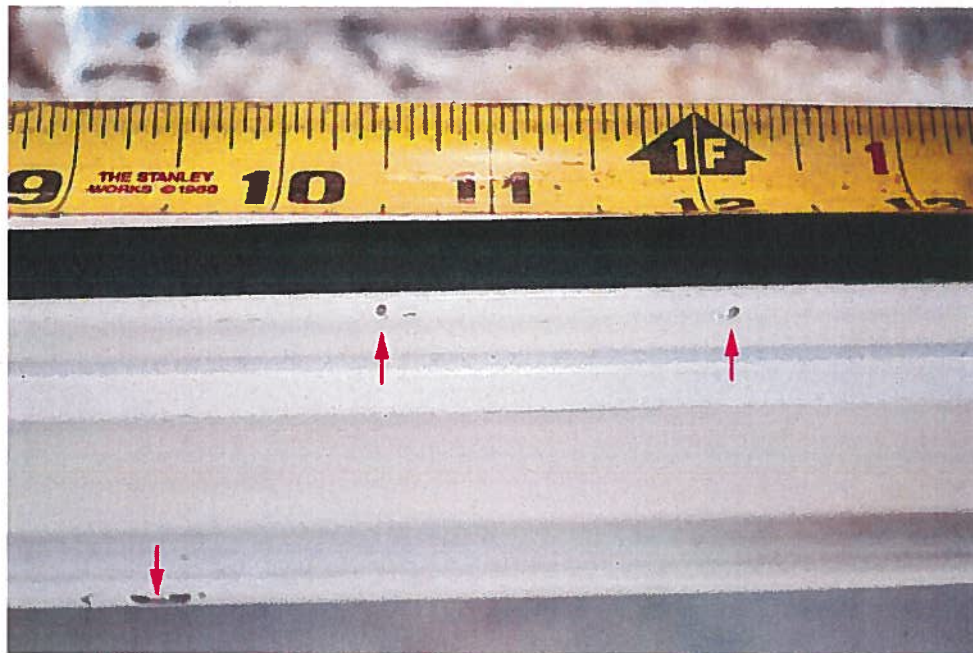
Figure 15: Unused Schreder wireway handling damage to white coating, as-received, arrows.

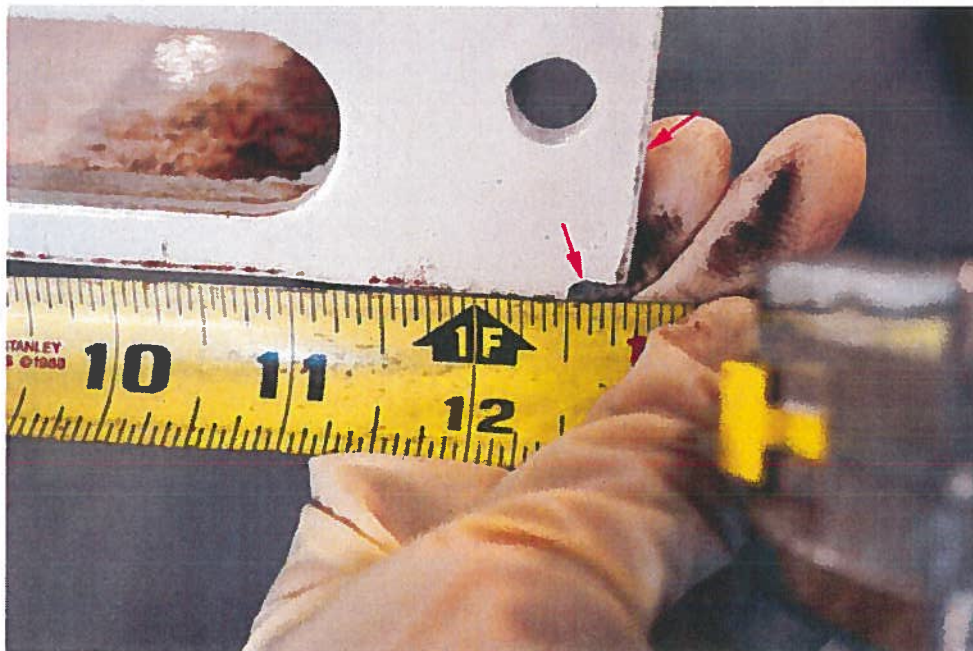
Figure 16: The end caps and most edges of the unused Schreder wireway exhibited mechanical damage to the coating, arrows.

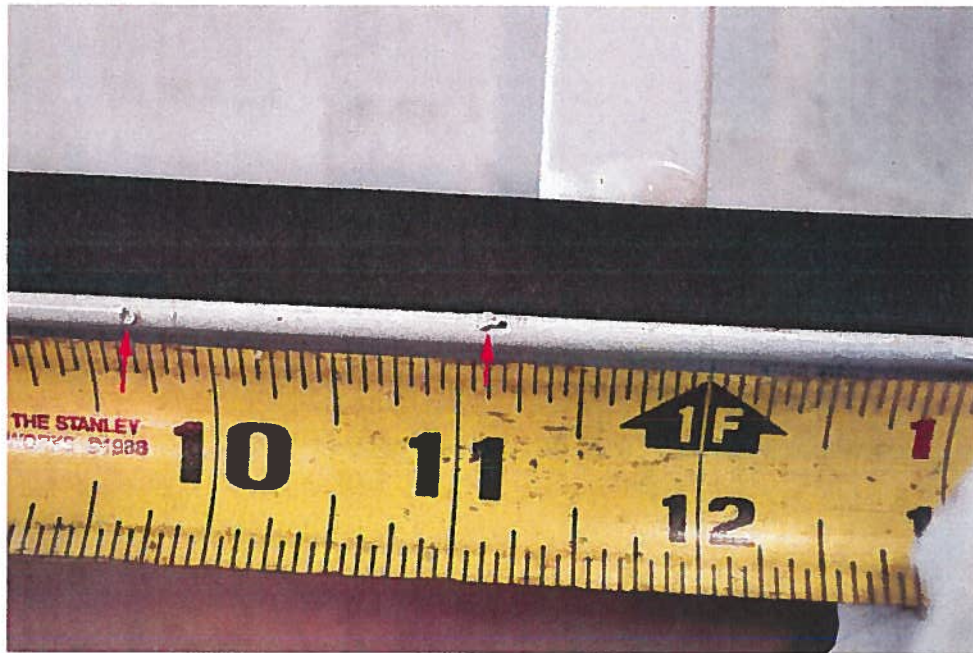
Figure 17: Typical edge damage to coating on both unused wireways, arrows.

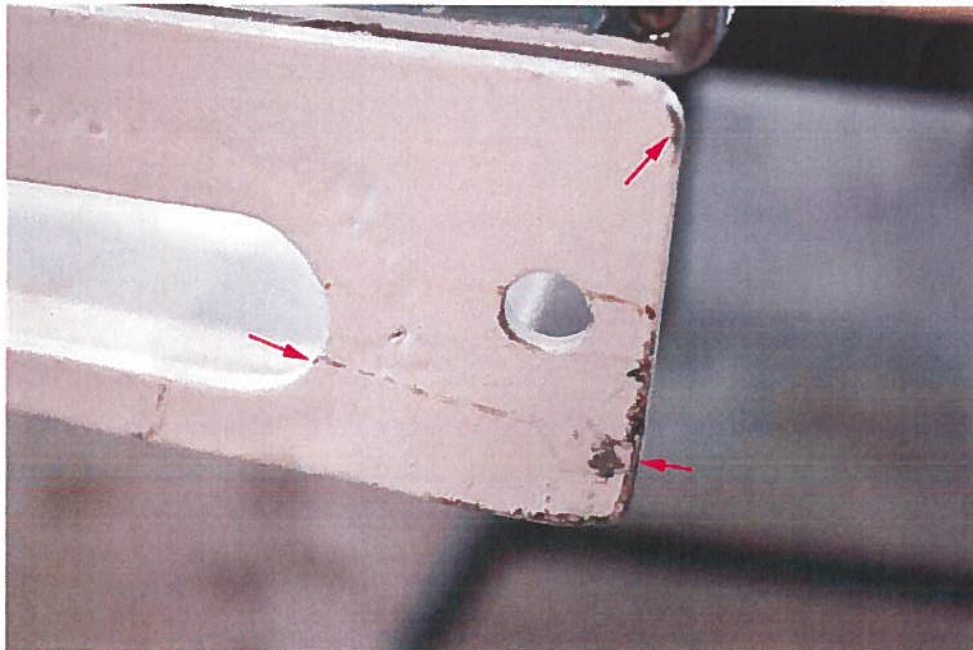
Figure 18: The unused NuArt wireway exhibited mechanical damage similar to the Schreader, arrows.

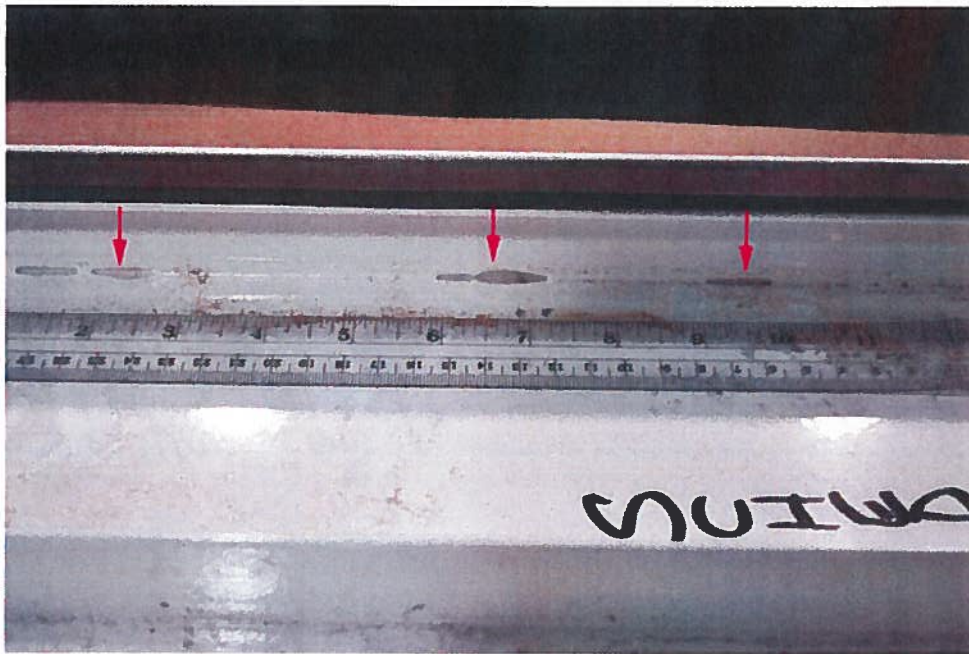
Figure 19: The unused Schreader wireway possessed large gaps in its coating at an interior recess, arrows.

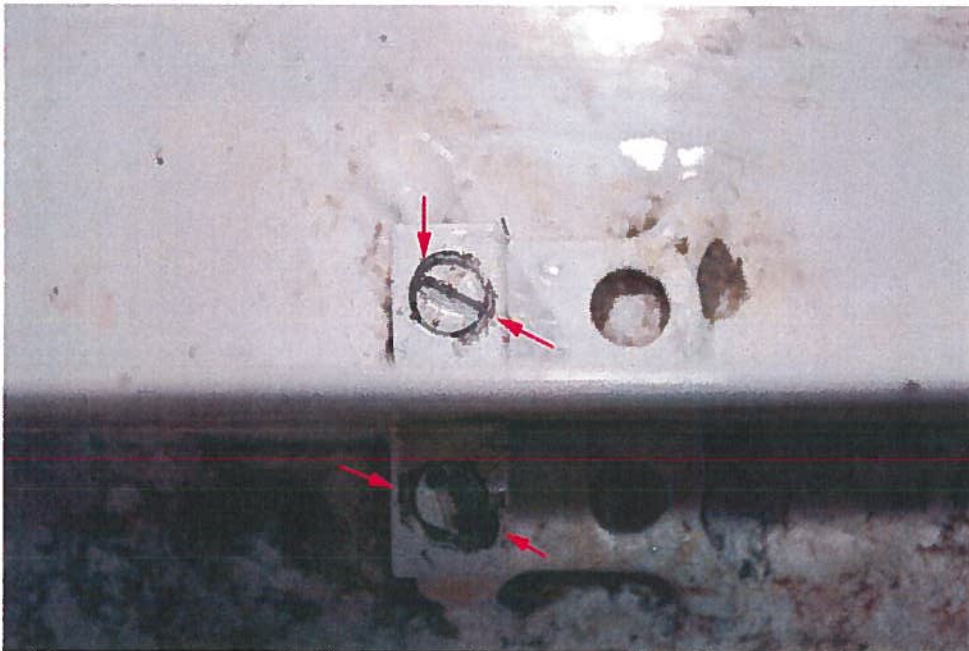
displayed absence of coating from the coating application process. Breaching of coating was noted at the screwed on grounding lug locations. This condition indicates that during the screw installation operation the coating can be breached easily.

Figure 20: Unused Schreader wireway: grounding lug at an interior surface. Note the breached coating, arrows, during installation of the screws.

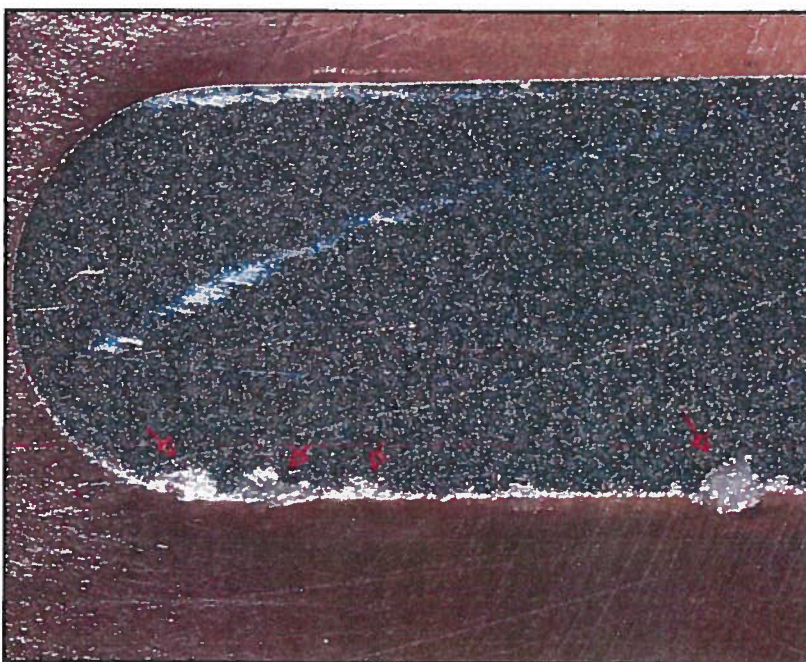
Figure 29: Sample #1: Mount 1-3. Tab opposite to the lip. Arrows point to areas with evidence of corrosion.

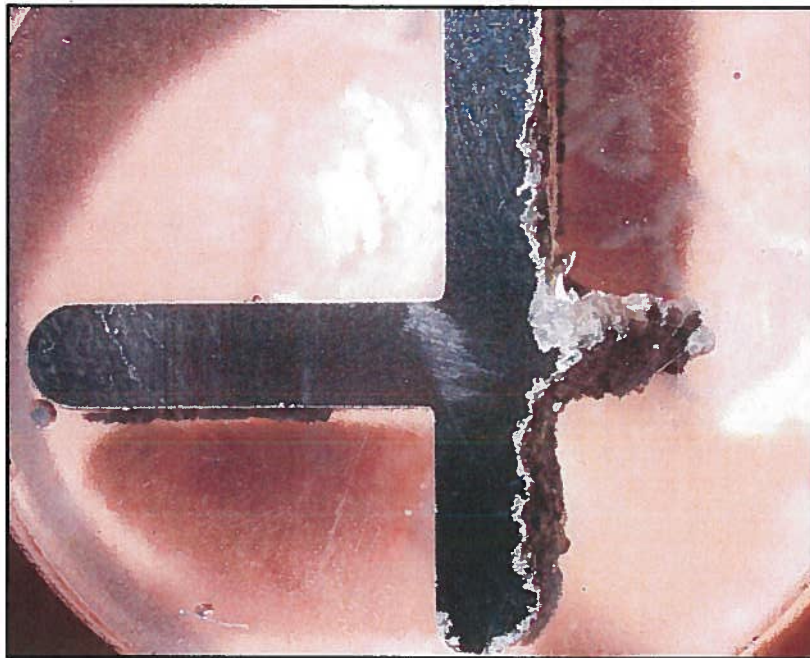
Examination of the mounts revealed significant corrosion of the wireway at the locations where the light fixture was attached to the 300-series stainless steel (SS) clips. The complete thickness of the wireway lip was consumed at these engagement locations resulting in separation of the light fixture from the wireway. Corrosion was also noted on areas adjacent to the failed lip location, but to a lesser degree.

Figure 30: Sample #1: Mount 1-1. This mount is through the wasted area where the clip was attached to the lip. Note completely consumed lip area with severe corrosion on adjacent surfaces.

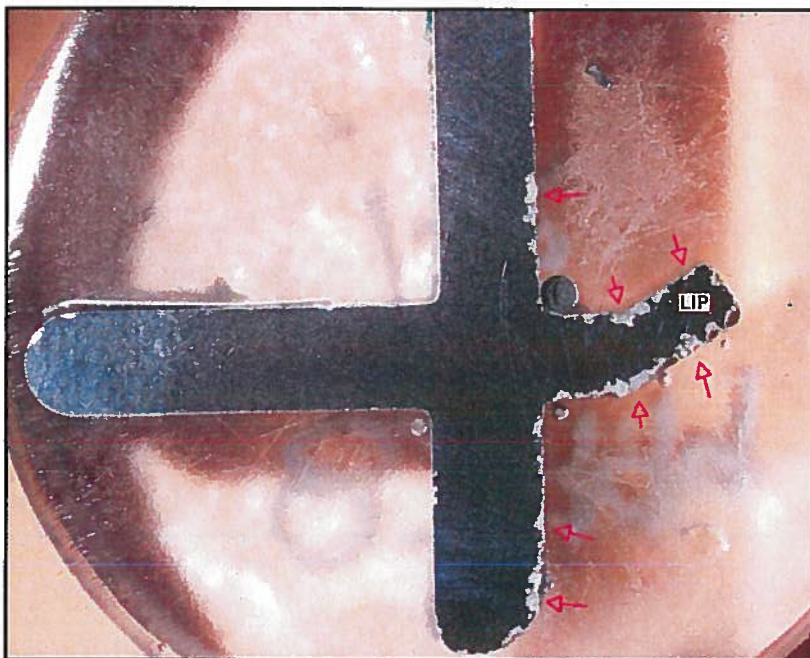
Figure 31: Sample #1: Mount 1-2. This area is next to the consumed lip location. Arrows point to corroded areas.

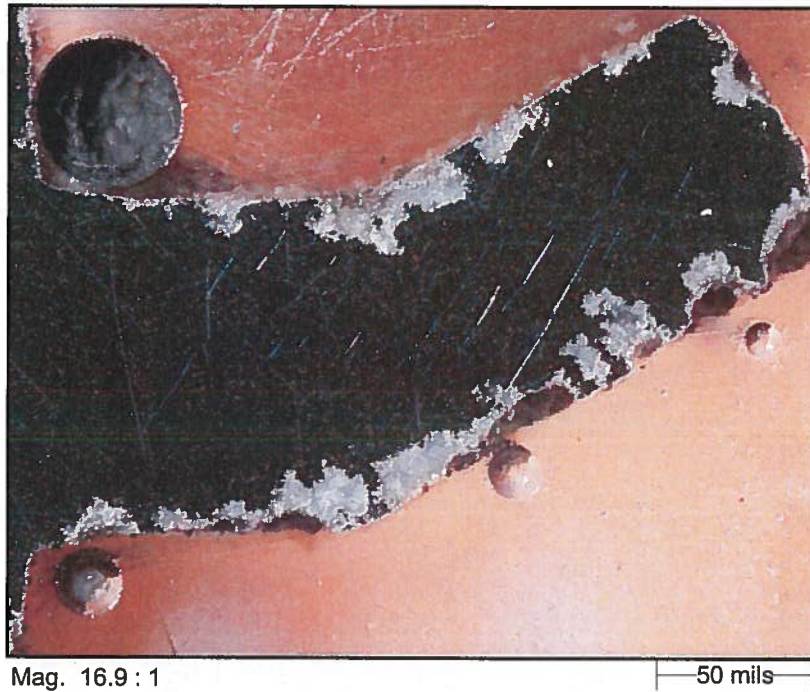
Figure 32: Sample #1: Mount 1-2. A higher magnification view of the lip location with corrosion.

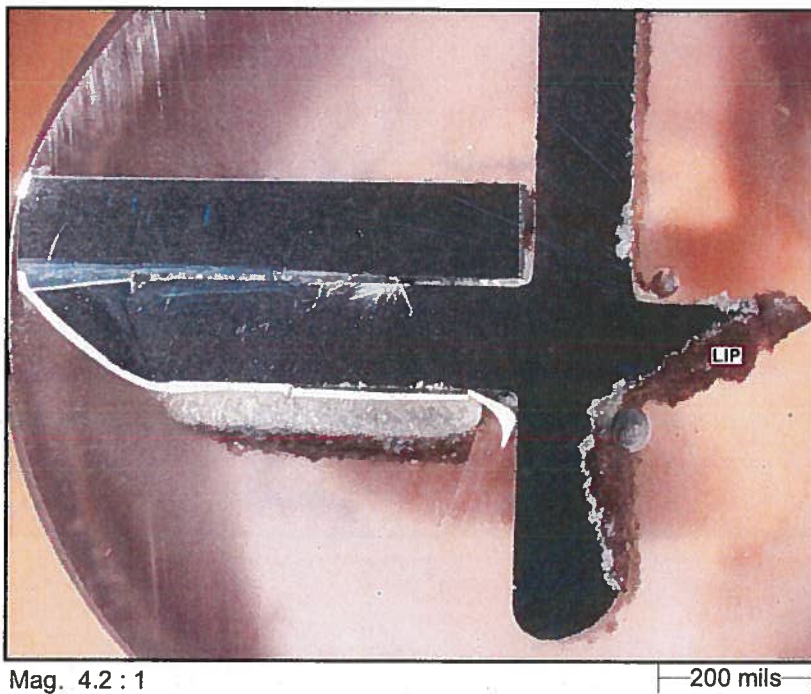
Figure 33: Sample #1: Mount 1-4. This mount is through another wasted area where the clip was attached to the lip. Note completely consumed lip area with severe corrosion on adjacent surfaces.

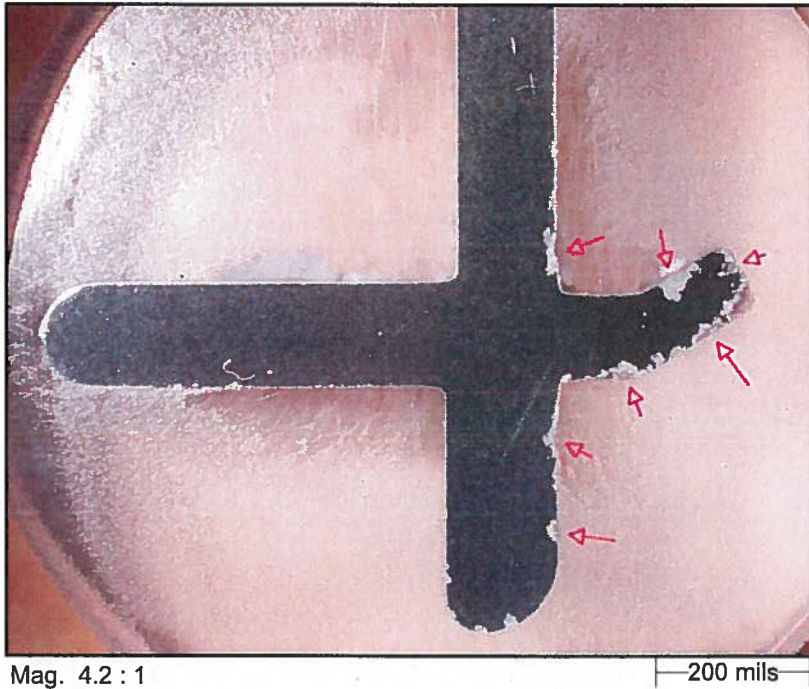
Figure 34: Sample #1: Mount 1-5. This area is next to the consumed lip location in mount 1-4. Arrows point to corroded areas.

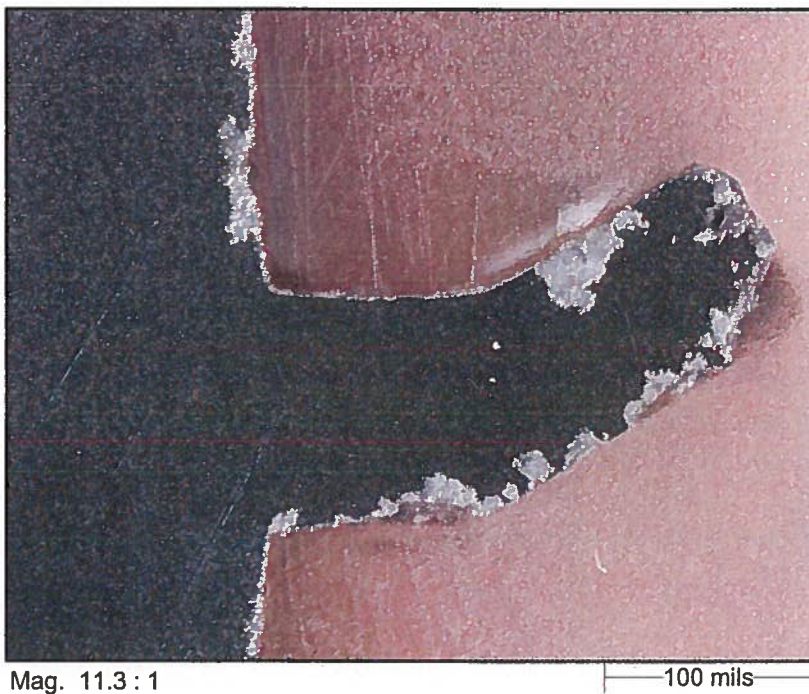
Figure 35: Sample #1: Mount 1-5. A higher magnification view of the lip location with corrosion.

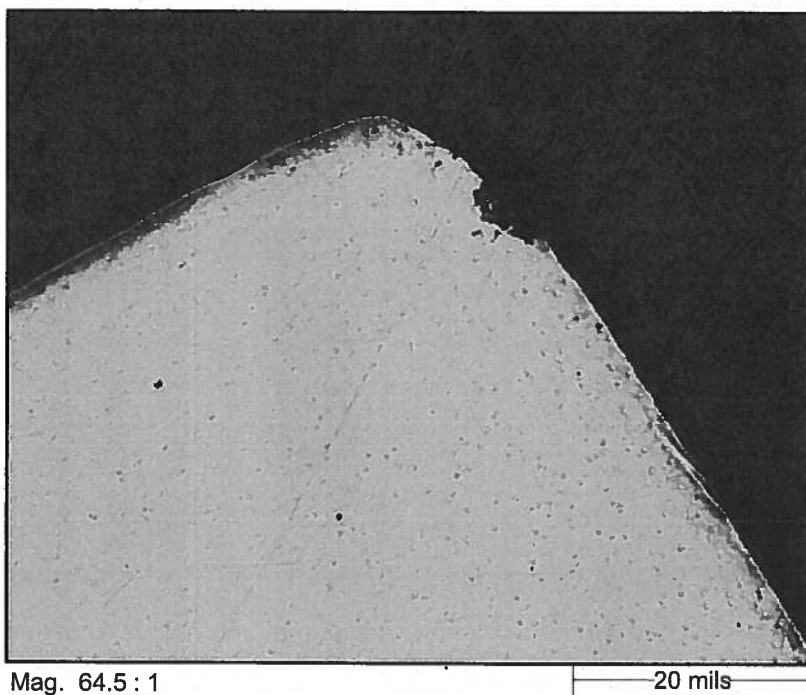
Figure 36: Sample #1:Mount 1-3; lip edge. Note some corrosion. Unetched.

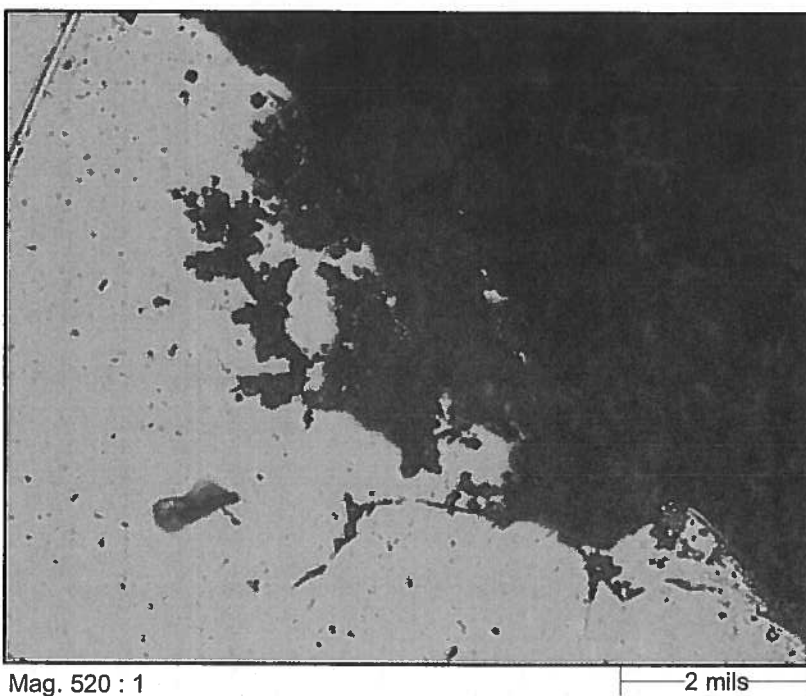
Figure 37: Sample #1:Mount 1-3; lip edge. A higher magnification view. Note some corrosion. Unetched.

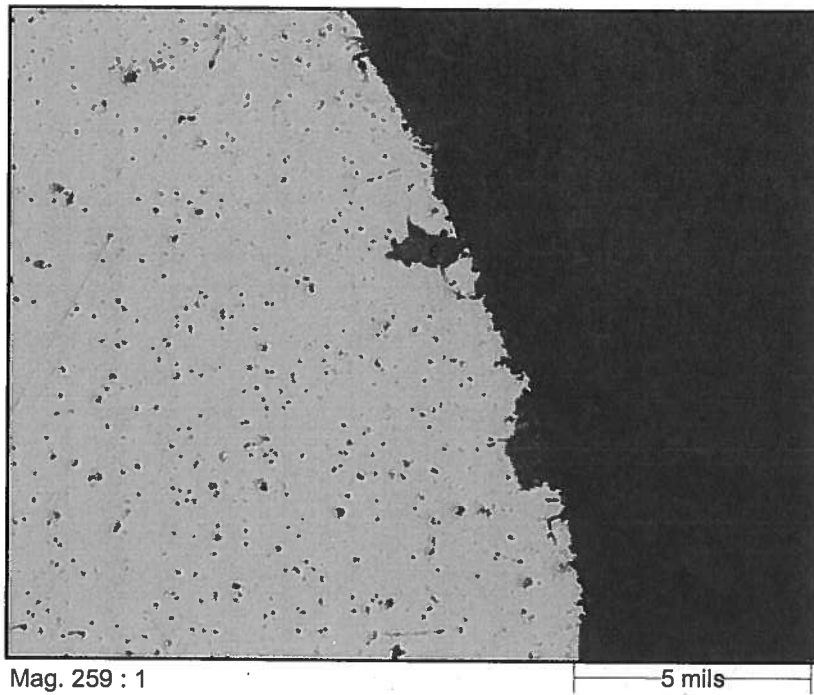
Figure 38: Sample #1:Mount 1-3; the other lip edge. Note shallow corrosion. Unetched.

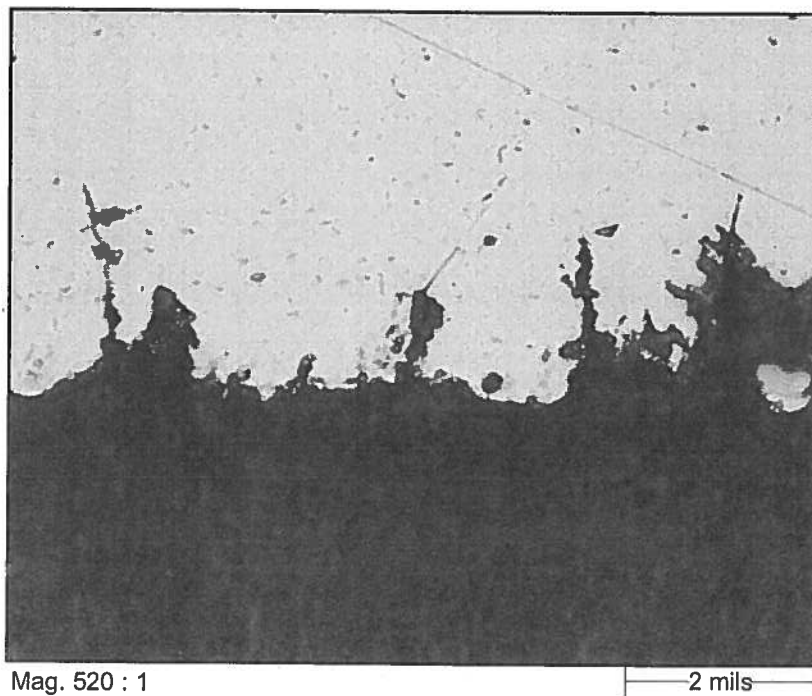
Figure 39: Sample #1:Mount 1-3; the tab area opposite to the lip area. Note some corrosion.

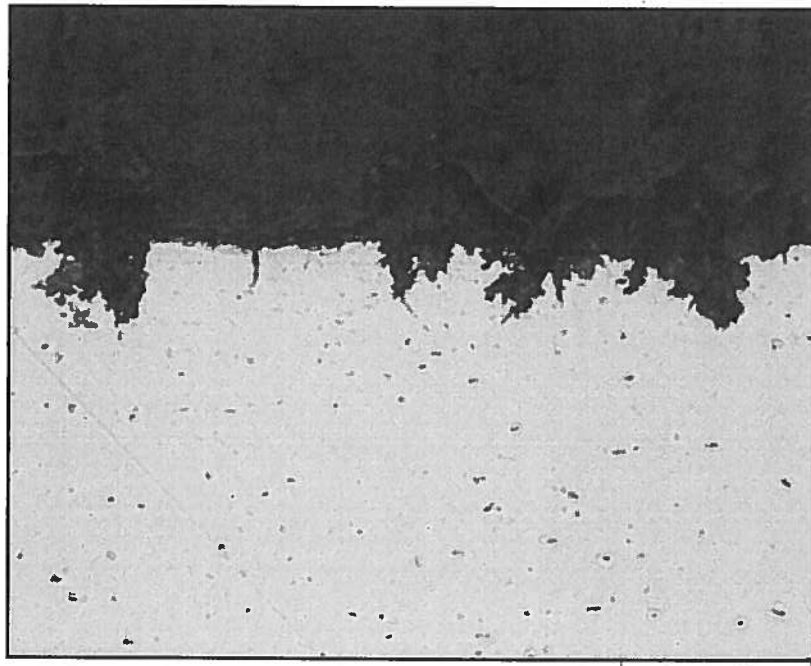
The cross-section away from the severely corroded areas showed initiation of corrosion in an intergranular mode, which progressed to a more pitting type general corrosion. Note that corrosion to a significant depth was not noted for the areas away from the engagement locations.

Figure 40: Sample #1: Mount 1-3; the tab area opposite to the lip area. Note initiation of corrosion in an intergranular mode progressing to pitting type. Unetched.

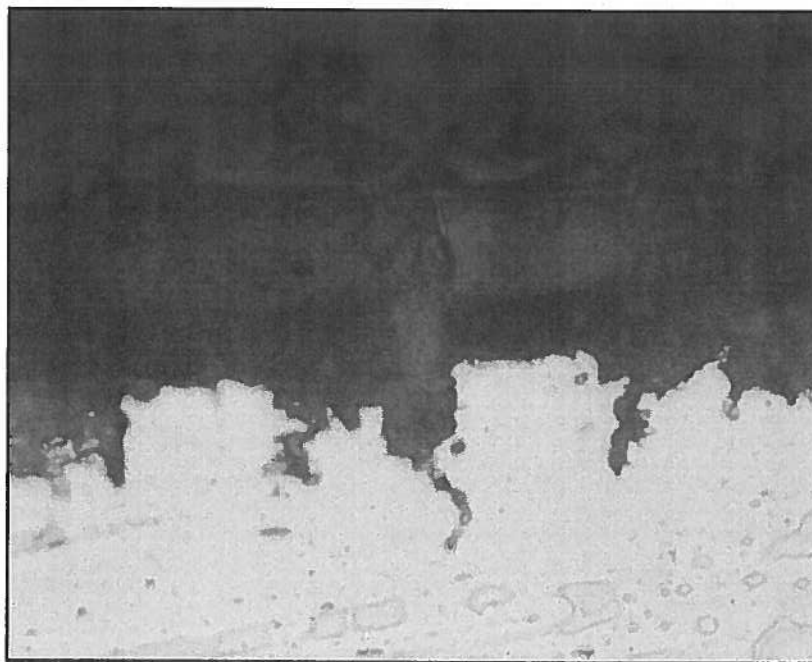
Figure 41: Sample #1: Mount 1-3; lip radius showing corrosion initiation.

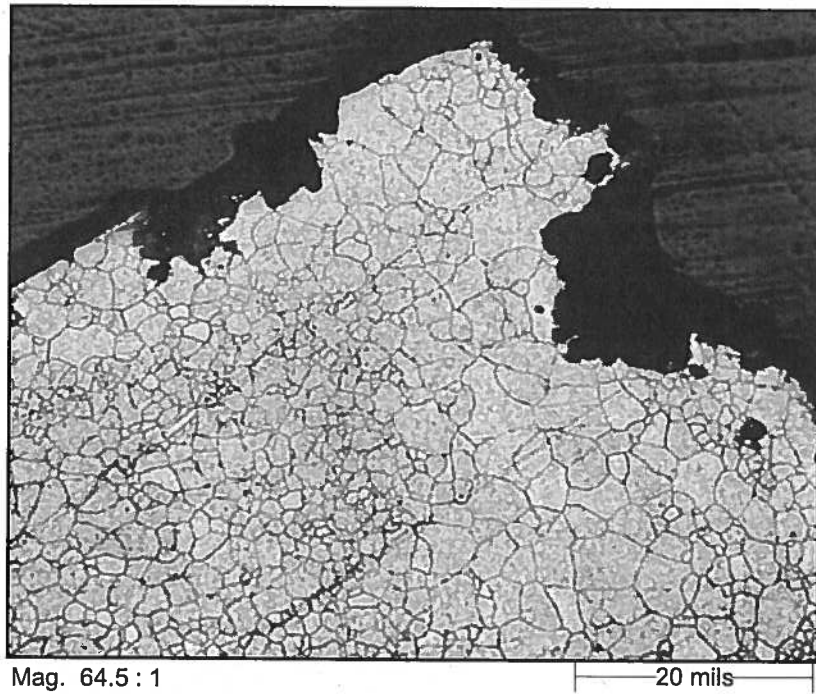
Figure 42: Sample #1: Mount 1-2; note significant corrosion on the lip. Etched.

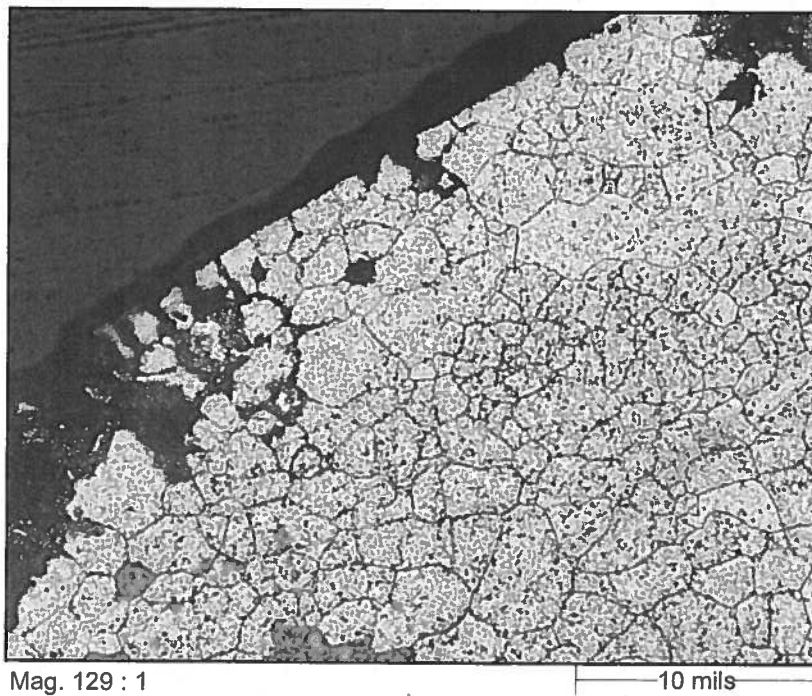
Figure 43: Sample #1: Mount 1-2; note significant corrosion on the lip. Etched.

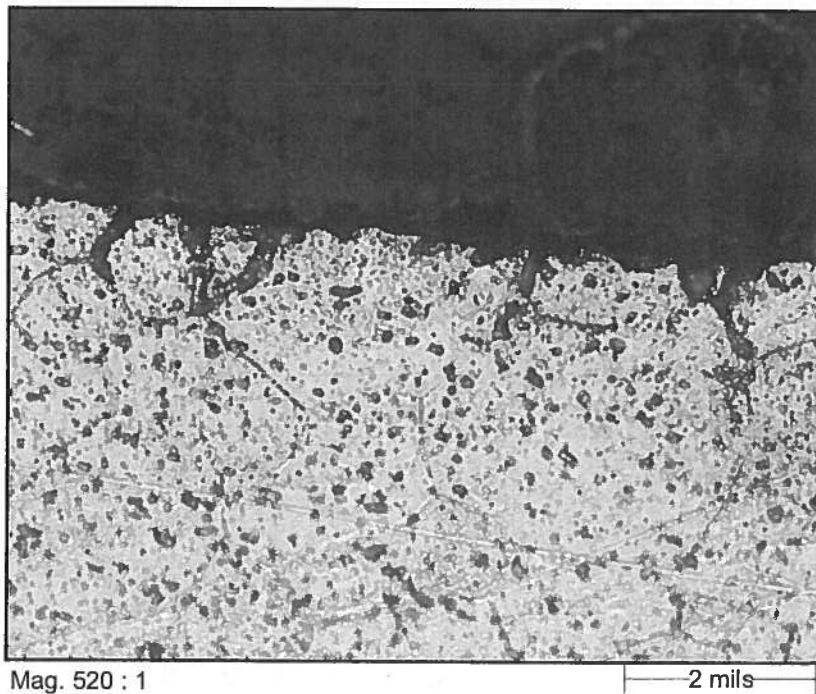
Figure 45: Sample #1: Mount 1-2; corrosion initiation in intergranular mode on lip radius . Etched:

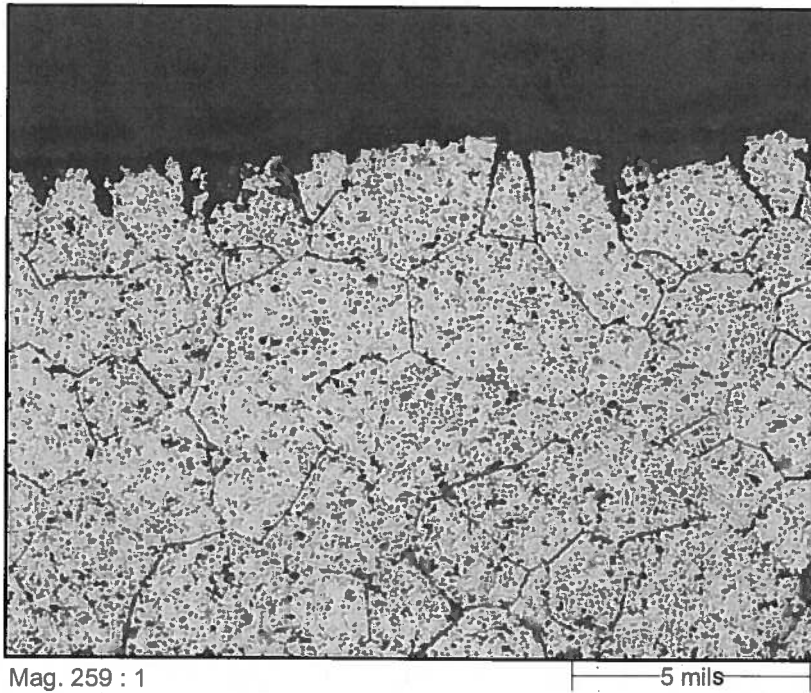
Figure 46: Sample #1: Mount 1-2; corrosion initiation on another surface. Etched.

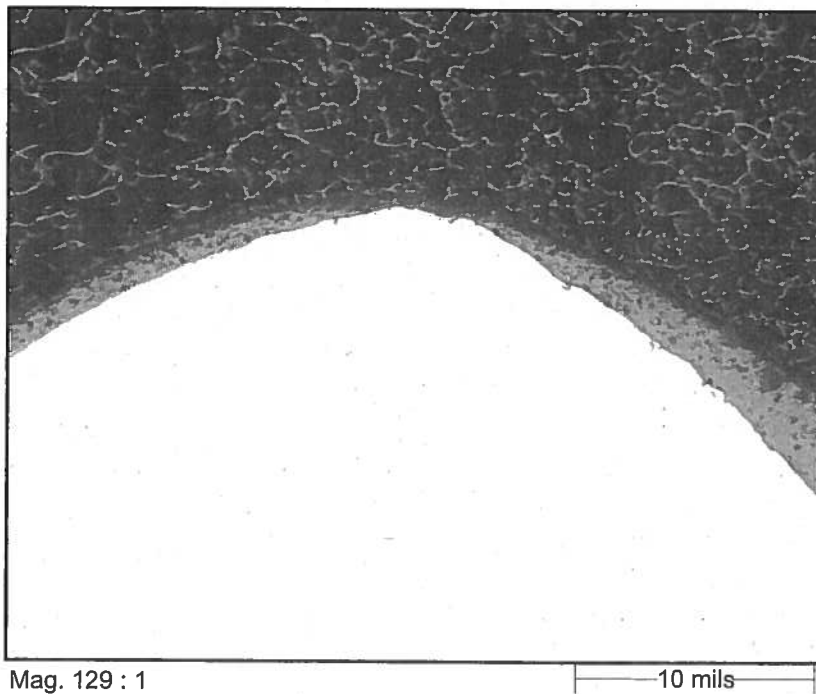
Figure 47: Sample #2: Mount 2-1; lip edge corner showing the thinner coating. Unetched.

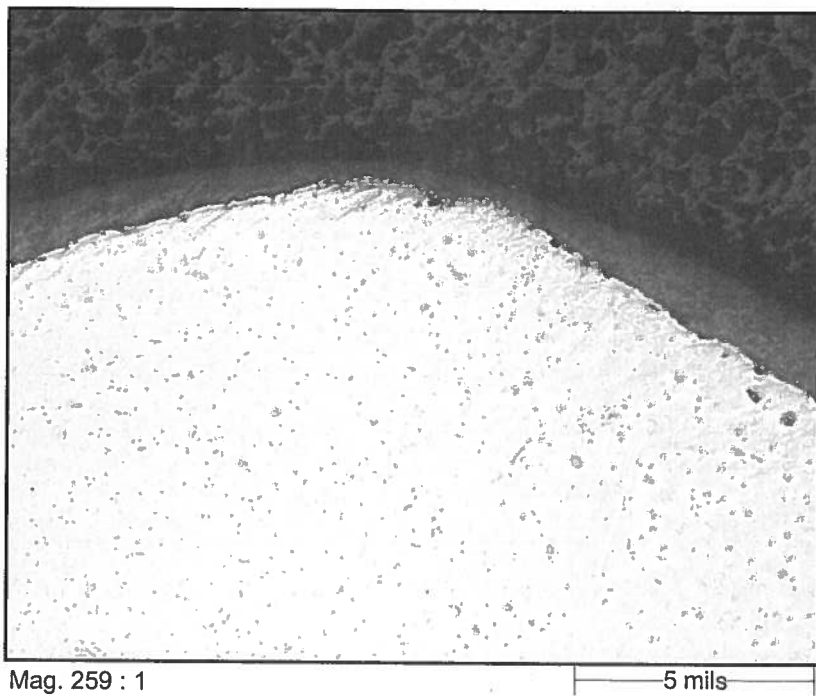
Figure 51: Sample #2: Mount 2-2; lip edge corner showing the thinner coating. Unetched.

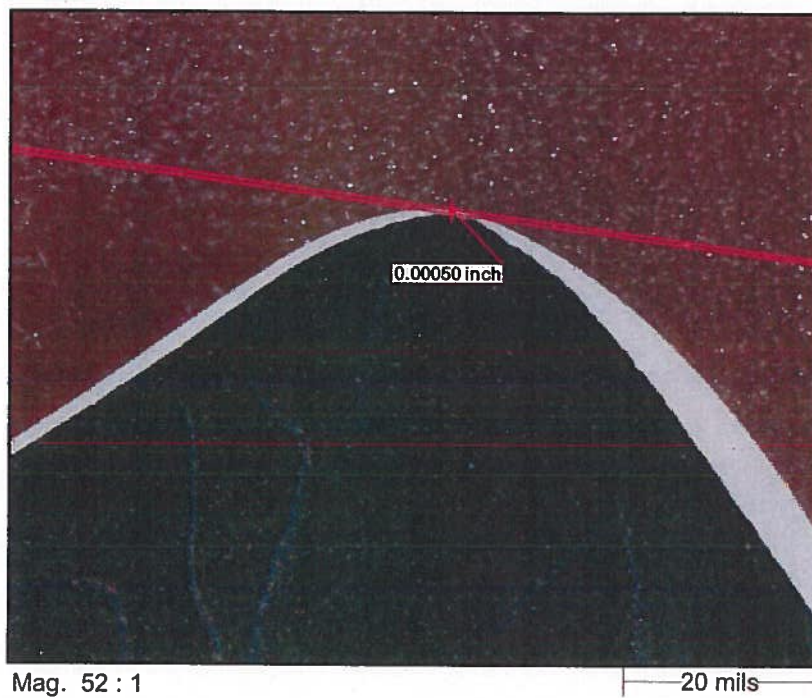
Coating thickness: Coating thickness varied significantly on the lip and adjacent areas. Special attention was paid to the lip area as this area revealed failure by corrosion. The coating appeared to be significantly thin at the edge of the lip. Note that typically for a spray powder coat, the edges/corners are prone to have thinner coating application. This is inherent to the coating process. Some of the radii areas revealed thicker deposition with many flat areas displaying variable coating thickness.

Figure 60: Sample #2: NuArt, new. Mount 2-2. A corner of the lip showed the coating thickness to be 0.0005".

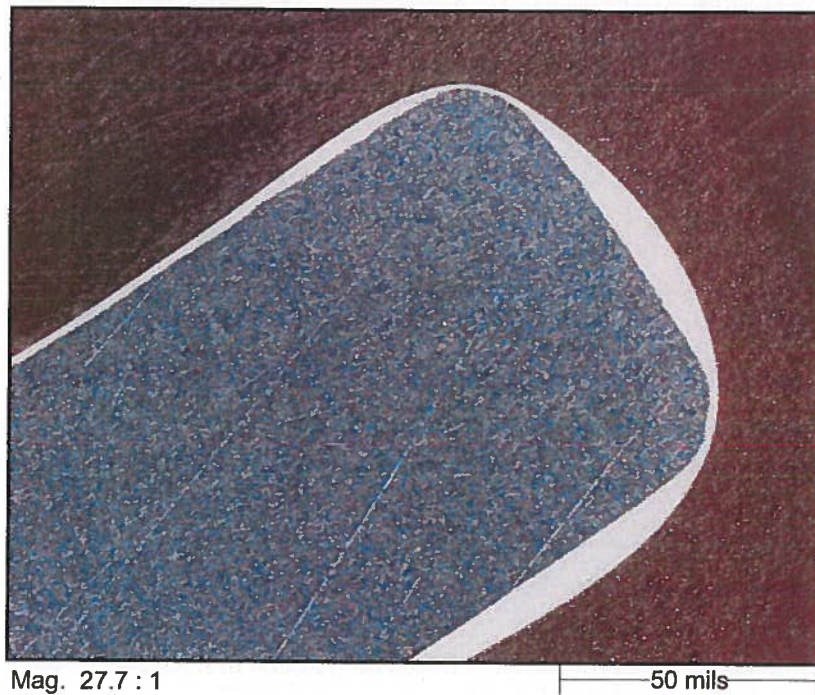
Figure 64: Sample #3: Schreader, new. Mount 3-2. A higher magnification view of the lip area. Note thin coating at the edges/corners.
